High-Temperature Bearing Failures- Engineering a Solution

By Eric Ford, Vice President of Sales and Marketing, Graphite Metallizing Corp.

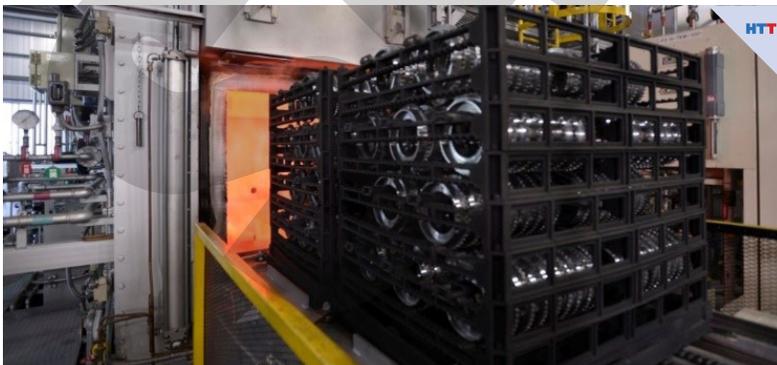
An example of a flame curtain in an industrial setting (Photo source: Graphite Metallizing Corp)

This large manufacturing plant runs automated gas nitriding furnaces for treating their various engine components. A flame curtain, at the entrance to the furnace, produces a vertical stream of combustion products to minimize both the infiltration of room air into the furnace chamber and the disruption of the furnace atmosphere inside. The

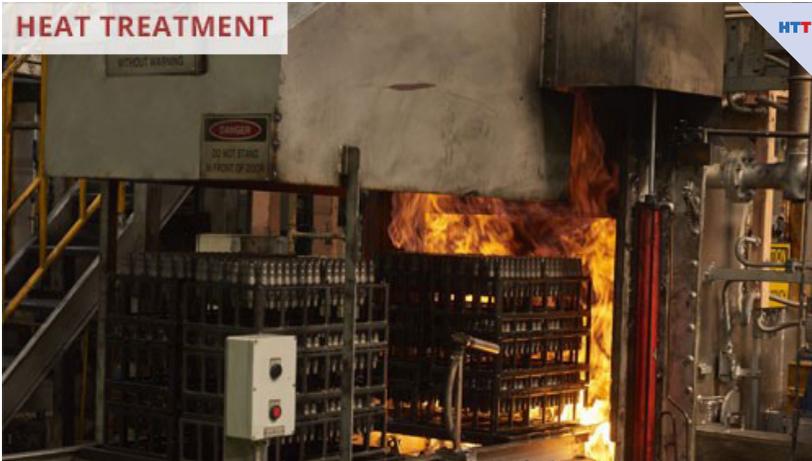
The conveyor transporting the parts has bearings to support the load and convey the product through the furnace. (photo source: Graphite Metallizing Corp)

bearings for the conveyor rollers, closest to the flame curtain, are subjected to intense heat for a short period of time, about 30 seconds, which is enough to cook the grease in the bearings and degrade their performance.

The plant was having trouble with the repeated failure of the rolling element bearings, located just prior to the furnace's flame curtain. These bearings were failing within six months, causing unscheduled maintenance and downtime. Though there was an automatic grease system, temperatures of approximately 300°F resulted in the grease being cooked away rapidly, resulting in conveyor roller seizure.

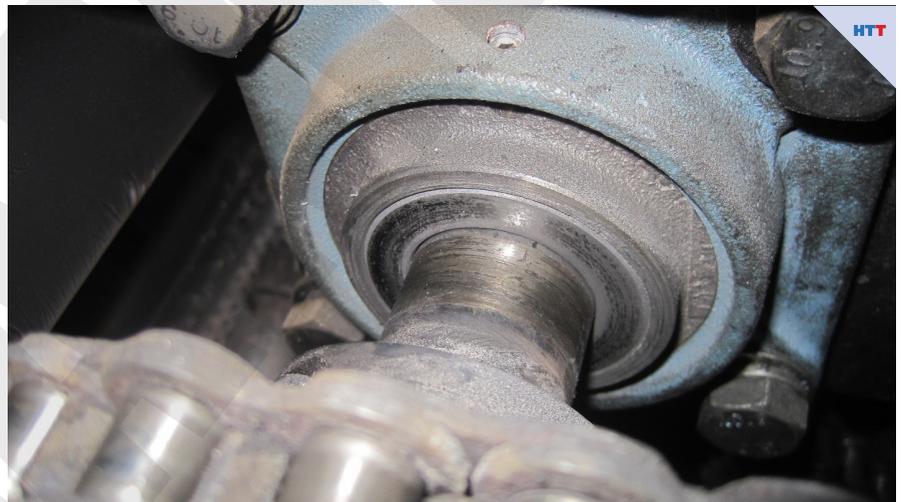
Graphalloy 4-bolt flange block in service. (photo source: Graphite Metallizing Corp)

Soon after the show, company representatives went to the plant and proposed a simple drop-in replacement for the current greased bearing flange block assemblies. The production manager agreed to test a few of the company's 4-bolt flange blocks with copper bushings, and they were installed a few weeks later.

The original bearing assemblies, installed over six years ago, have been operating without a single failure or showing any appreciable wear.

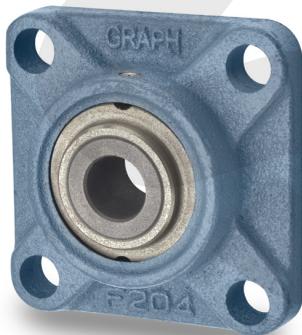
Flange Bush 845 (photo source: Graphite Metallizing Corp)
